# Assessment of Road Project for Accelerating Permanent Connectivity

Badkhola Takshar-Dulegaunda road of SNRTP sub-projects in Syangja district is the study area of my research.

The Badkhola-Takshar Road having total length 20.6 KM starting from Badkhola bazar to Kaule. Badkhola-Taksar-Dulegaunda road is the part of the road connecting Badkhola bazaar at Putalibazaar Municipality of Syangja district link from Siddhartha Highway. The section is starts from Devisthan (Ch: 8+000, Putalibazaar Municipality ) and ends at Taksar ,kaule settalement (Ch 18+000, Putalibazaar Municipality )The DTMP code of this road is (39DR030). Total length of this section is 10.00 km. The passing settlements are: Devisthan, Dhadhkelne, Thuladihi, Govinde Bhanjyang, Kaule, Taksar.

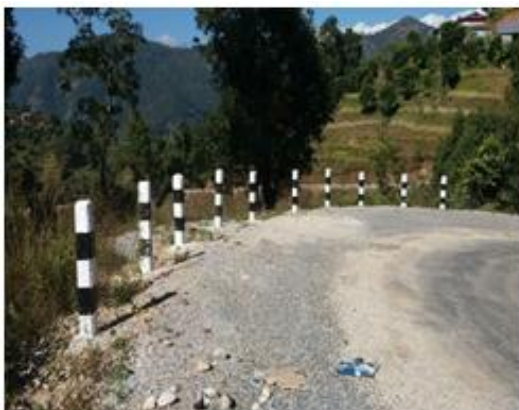
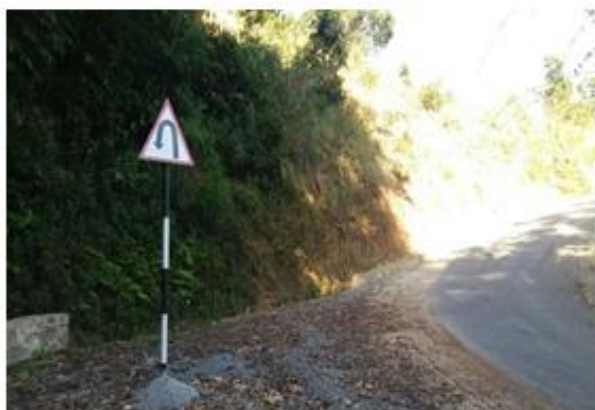
**Fig-3: Installation of Traffic Sign and Delineator post**

S.N	Safety works	As per Contract (No)	Actual on site (No)	Remarks
1.	Traffic sign	30	28	
2.	Kilometer stone	9	9	
3.	5 Km stone	2	2	
4.	Delinator post	250	221

Traffic Sign are provided to control and guide traffic and to promote road safety. Traffic signal should be properly installed along the road so as to ensure a

Total cost allocation for road safety was NPR 5, 07, 000 which was only 0.7% of total estimated cost. So cost allocated for road safety works was not sufficient. The quantity estimate of traffic sign, delineator post was also not sufficient, from the field observation it was found that these are required in many

Traffic safety management of Badkhola-Takshar road project was found very poor due to low cost allocation. NPR 5, 000, 00.00 was allocated for 10 KM section. Traffic sign, delineator post installed in road is not sufficient. 25 no of traffic sign, 100 delineator post, 4 Safety reflector on sharp bends, and safety barriers on 3 places at stiff slop were required for proper safety management.

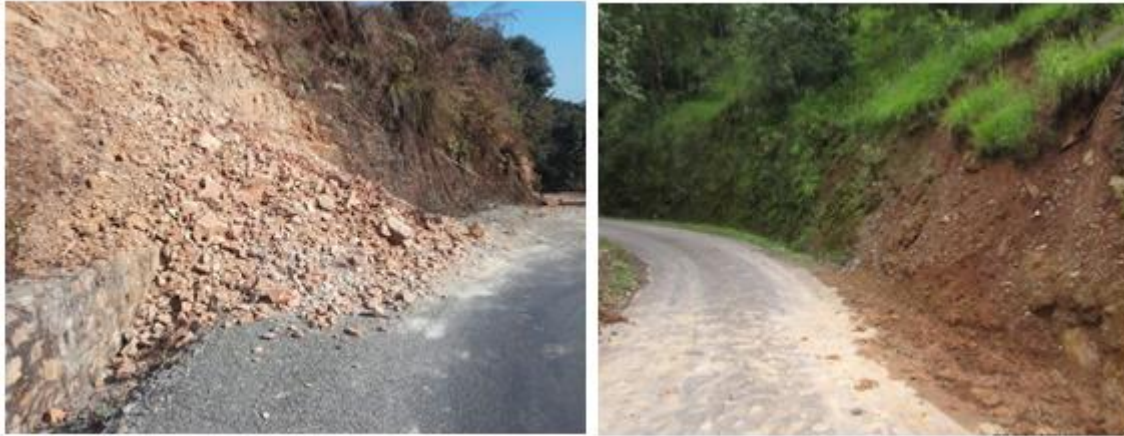
Fig-4: Landslide blocked the drain

place. Road maintenance after the construction was found very poor. Road needs routine and recurrent maintenance. The surface deterioration rate is increase day by day; landslide from the slop blocked the drain in many place and water flow over the road.

8.	Maintenance of road after completion of works was not done due to which road deterioration was increased day by day, drain blockage in different section grass and bushes covered the drain and road surface.	Need of routine and recurrent maintenance immediately.
