# Retrieval of Fractured Rotary Instrument from Root Canal: A Case Report

## CASE REPORT

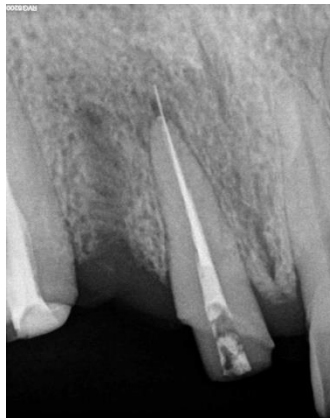
**Fig-1: Pre-operative radiograph showing fractured instrument extending beyond the canal**

A 35 year old female patient reported to Department of Conservative dentistry and Endodontics with the chief complaint of pain in upper front region of the jaw since 2 weeks. The patient's dental history indicated that the tooth had undergone root canal treatment 1 month back. During clinical examination the tooth was sensitive to percussion and a temporary closed dressing was evident. Intra-oral periapical (IOPA) radiograph was taken and it was revealed that there is root canal treatment performed on the right maxillary central incisor (tooth no. 11) also the separated instrument in the canal extending beyond the apex (Figure-1). Local anaesthesia was administered after rinsing the patient's mouth with 0.2% chlorhexidine and isolation was done with rubber dam. Temporary dressing was taken out and gutta-percha was removed from the canal using H-files, modified Gates Glidden drill (size 3, Dentsply Maillefer, Ballaigues, Switzerland) was used to create a staging platform. After staging, ET25 tip of Endo Success<sup>TM</sup> Retreatment ultrasonic file (Figure-2) was attached to

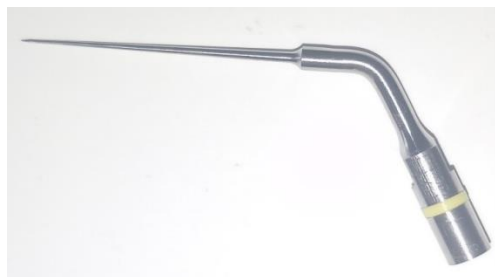
**Fig-2: ET25 ultrasonic tip**

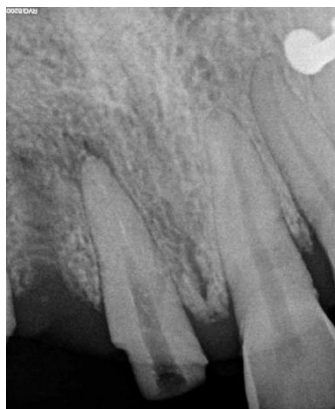
**Fig-3: Radiograph showing retrieval of fractured instrument from the root canal**

the ultrasonic device and was activated first at the inner dentinal wall of the canal to create approximately 1.0 mm deep pocket from the severed surface of the file fragment. EDTA solution was introduced in the canal so that the cavitation and acoustic streaming effect of ultrasonics has been enhanced. Ultrasonic vibration was applied and moved in “push and pull” motions between the fragment and the inner wall of the canal until the separated instrument jumped out of the canal. A radiograph was taken to confirm retrieval of the file fragment (Figure-3). The retrieved file fragment was approximately 10 mm long (Figure-4). After instrument retrieval, working length was determined using

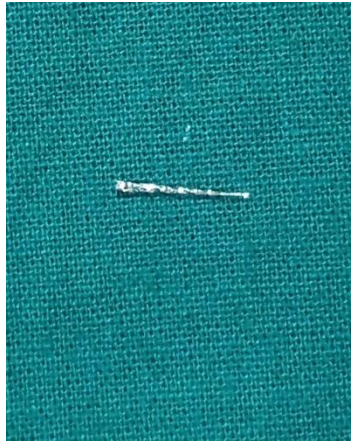
**Fig-4: Retrieved file fragment approximately 10 mm long**

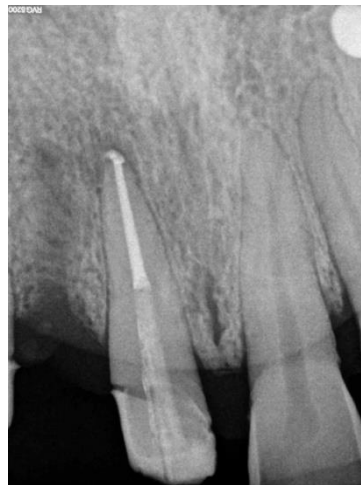
**Fig-5: Post-operative radiograph**

radiograph and electronic apex locator (Propex, Dentsply, Maillefer, Ballaigues, Switzerland). Chemo-mechanical preparation was performed using rotary NiTi files (ProTaper, Dentsply Maillefer, Ballaigues, Switzerland). 5.25% sodium hypochlorite and 2% chlorohexidine were used for irrigating the root canals and calcium hydroxide as an intracanal medicament was placed. In the second visit, obturation was carried out by warm vertical compaction technique using gutta percha points (ProTaper, Dentsply, Maillefer, Ballaigues, Switzerland) and Sealapex sealer (Kerr, SybronEndo) (Figure-5). Fiber post was cemented followed by composite restoration.
