Harmonizing the Smile: Esthetic Diastema Closure with a Crown–Veneer Approach - A Case Report

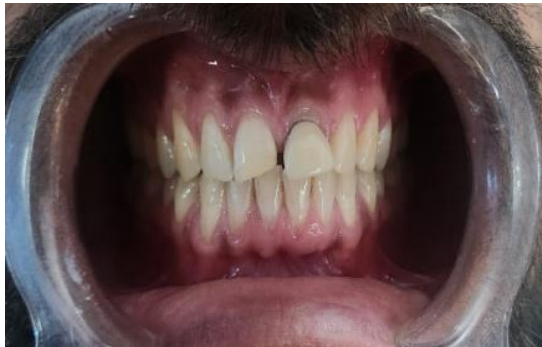
Figure 1: Pre operative Clinical Photograph

Intraoral examination revealed the presence of a crown in tooth 21 and an Ellis Class II fracture in tooth 11(Fig-1). Pulp vitality testing using a cold test elicited a positive response in both teeth 11 and 21, suggestive of vital pulp tissue. Preoperative radiograph demonstrated a full-coverage crown on tooth 21 and the periapical area appeared within the normal limits (Fig-2).

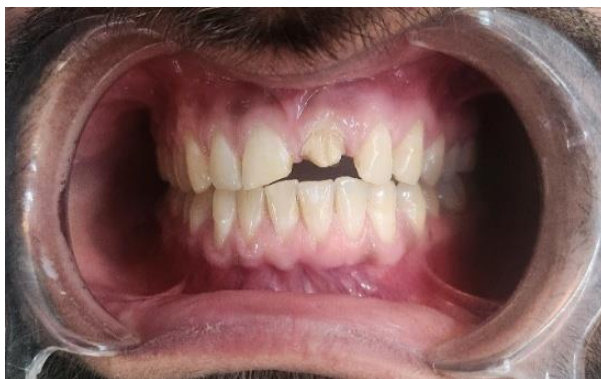
Figure 3: Clinical Photograph after crown removal

The treatment was initiated with removal of the existing crown on tooth 21. The crown was sectioned sequentially on the facial, incisal, and palatal surfaces along its long axis using a tungsten carbide crown-cutting bur (Eagle Dental Burs) in a high-speed handpiece under copious water coolant. Sectioning was performed from the cervical margin toward the incisal edge until the luting cement layer was exposed, taking care to avoid damage to the underlying tooth structure. A blunt hand instrument was then introduced into the sectioned grooves, and controlled wedging force was applied to separate and dislodge the crown. The sectioned crown fragments were subsequently removed, and residual luting cement was carefully cleaned from the tooth surface (Fig-3). A post–crown removal radiograph demonstrated an attempted access opening in the coronal portion of tooth 21; however, no evidence of periapical pathology or root fracture was observed (Fig-4)

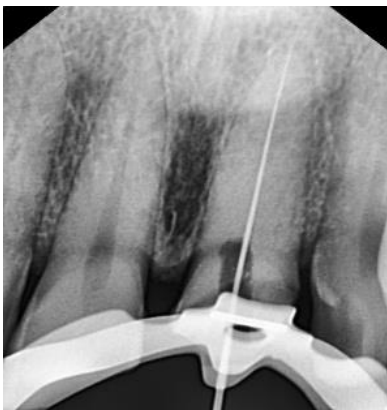
Fig. 5: Working Length

Considering the presence of an attempted access cavity preparation evident on the radiograph, endodontic treatment was planned for tooth 21. Local anesthesia was achieved using 2% lignocaine with 1:100,000 epinephrine, after which the tooth was isolated using a rubber dam. Endodontic access was conservatively refined with a round diamond bur in a high-speed handpiece under copious irrigation. Canal patency was initially negotiated with a #10 K-file. The working length was determined using an electronic apex locator and further validated with a radiographic method, establishing a final working length of 21 mm (Fig -5). Biomechanical preparation of the root canal was performed using the NeoEndo (Dentsply) rotary system. After establishing canal patency with a #10 K-file, sequential instrumentation was carried out up to the 25/6 % following the manufacturer's recommended rotational

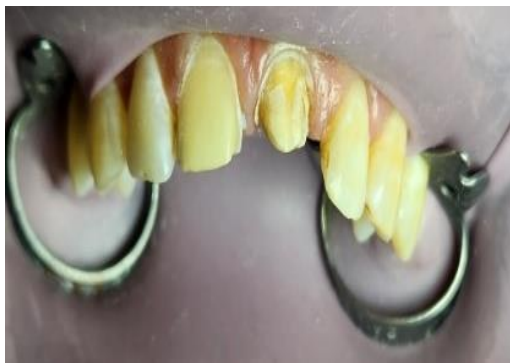
Fig. 8: Crown Preparation of 21 and veneer preparation of 11

At the subsequent appointment, both teeth 11 and 21 were prepared under split rubber dam isolation to maintain a clean and dry operative field. The dam was anchored on the first premolars of both quadrants, with an interproximal cut from canine to canine to allow unobstructed access and visualization of the anterior teeth. Tooth 21 was prepared for an IPS e.max full-coverage crown, with occlusal reduction of 1.5–2.0 mm and axial reduction of 1.0–1.5 mm using a tapered round-end diamond bur (Mani, Japan), and a 0.8–1.0 mm chamfer margin was created with a round-end shoulder diamond bur (Eagle Dental, USA). Tooth 11 was

prepared for an IPS e.max veneer, with 0.5–0.7 mm facial reduction, 0.3–0.5 mm gingival chamfer, and incisal reduction of 1.0–1.5 mm using a fine-grit diamond bur (Mani, Japan). All line angles were rounded, and surfaces polished to optimize ceramic adaptation (Fig-8). Shade selection was performed using the Ivoclar shade guide, and both teeth were recorded as shade A2 (Fig-9). Following preparation and shade recording, digital impressions of both teeth were obtained using the 3Shape TRIOS (3Shape, Copenhagen, Denmark).

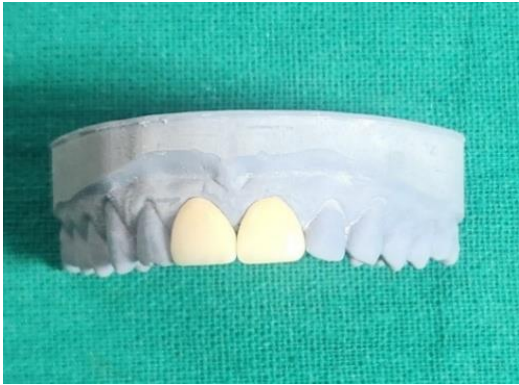
Fig. 10: Fabricated crown and veneer

At the third appointment, the crown and veneer, fabricated in the dental laboratory (Fig -10), were received and tried in under split-dam isolation to assess fit, marginal adaptation, and esthetics (Fig -11). The prepared tooth surfaces were etched with 37% phosphoric acid (Ivoclar, Liechtenstein) for 15 seconds, rinsed, and gently air-dried (Fig-12) A bonding agent (Adper Single Bond 2, 3M ESPE, USA) was applied to

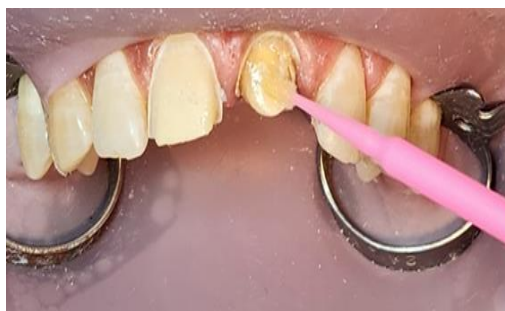
Fig. 13: Bonding of etched surface

the etched surfaces (Fig-13) and light-cured according to the manufacturer's instructions.

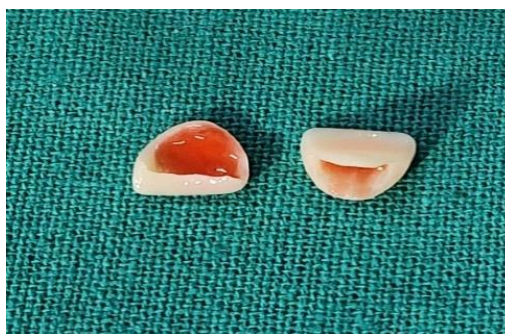
Fig. 14: Application of HF

The internal surfaces of the lithium disilicate restorations were etched with 3% hydrofluoric acid (IPS Ceramic Etching Gel, Ivoclar, Liechtenstein) for 20 seconds (Fig -14), rinse thoroughly, and dried. A silane coupling agent (Monobond Plus, Ivoclar,

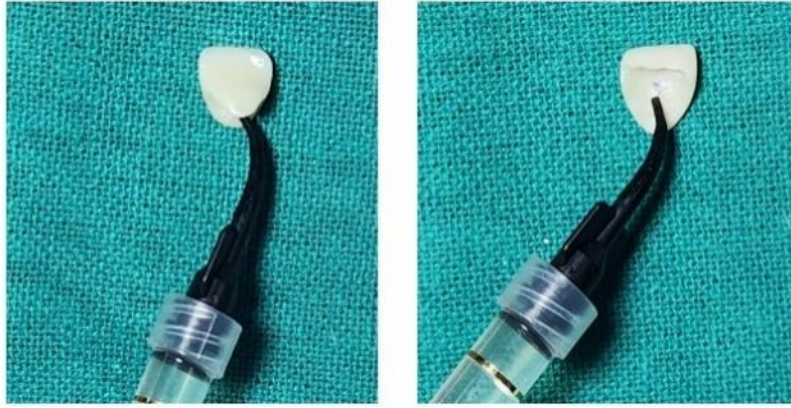
Fig. 15: Application of silane coupling agent

Liechtenstein) was applied to the etched ceramic surfaces and allowed to react for 60 seconds (Fig-15). The restorations were then seated using a dual-cure resin cement (Variolink Esthetic DC, Ivoclar, Liechtenstein), and excess cement was carefully removed. Each restoration was light-cured from multiple directions to ensure complete polymerization. Occlusion

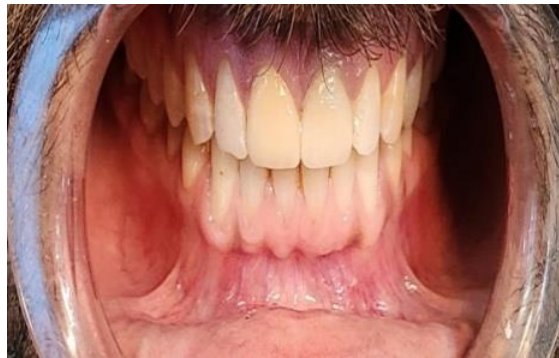
Fig. 16: Clinical photograph after cementation

was checked, and final adjustments were made, completing the definitive cementation of the IPS emax Venner and crown. Post-cementation, clinical photographs were taken to document the final esthetics (Fig- 16) and a periapical radiograph was obtained to confirm proper seating and marginal adaptation of the restorations (Fig -17).

Post-cementation evaluation through clinical photography and radiography confirmed satisfactory seating, marginal adaptation, and esthetic integration of the restorations. Radiographic assessment remains essential in verifying correct fit and detecting any residual gaps or structural issues that could compromise long-term outcomes.
